Sigtronics Panel Mount Intercom Sidetone Modification

Intercom Models: **Sport 200** Circuit Board 1440 S/N 6202355 - to - 6202992
SPA-400* Circuit Board 1440 S/N 6053486 - to - 6069005
SPA-600* Circuit Board 1440 S/N 1101839 - to - 1102527
SDB-800 Circuit Board 1440 S/N 1151004 A & B - to - 1151485

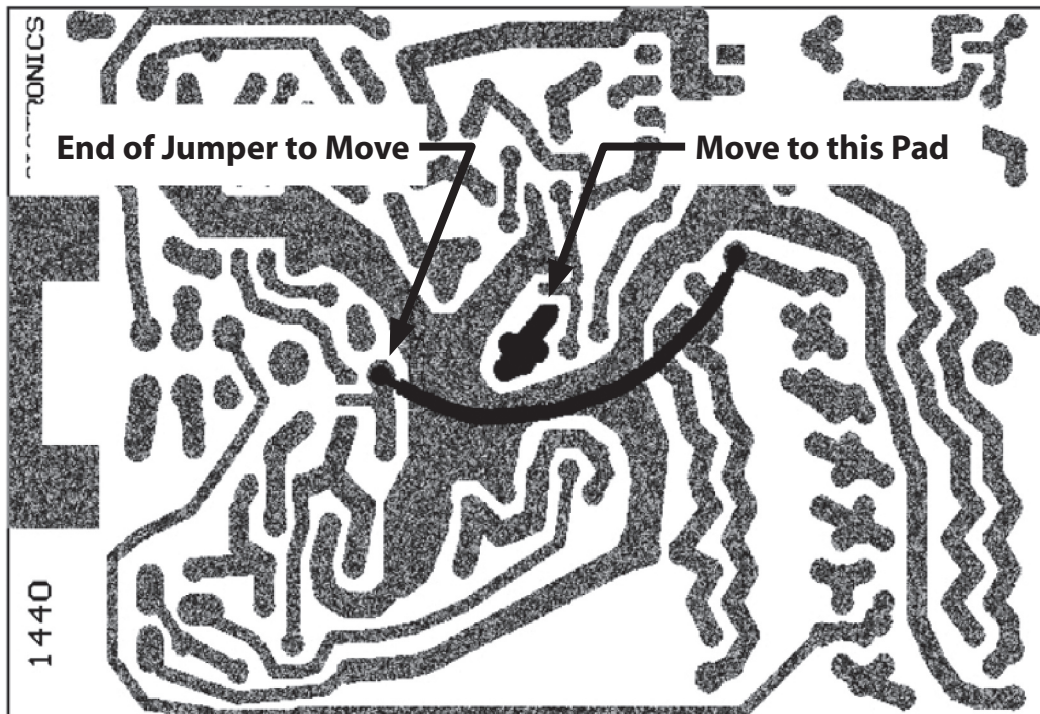
Most aircraft radios, when transmitting, provide what is called "side-tone". Without side-tone, you will not hear yourself or your co-pilot transmit to ATC. This can be distracting, especially during instruction, because no one on the intercom will hear the out going transmission side of the radio conversation. Some aircraft radios do not provide this function, other radios are designed to drive only one headset. Therefore, if you have such a radio, the side-tone may be extremely weak or non-existent. If this is the case and the side-tone is absent or cannot be turned up in the radio(s), a simple modification can be performed within the intercom to simulate side-tone.

To complete the circuit board modification, remove the three screws securing the bottom cover to the case and carefully lift the cover from the case. Locate the jumper wire (usually brown in color) on the solder side of the circuit board. Note that the circuit board does not need to be removed from its case to complete the "side-tone" modification. Unsolder the wire from the solder trace at the end closest to the controls. Move the free end of the wire to the solder pad indicated in the attached drawing and solder the wire to the trace at the location specified.
