You can not adjust the wheel bearing on the Twin Cessna.

***Solution: True-Lock's Axle Nut System***

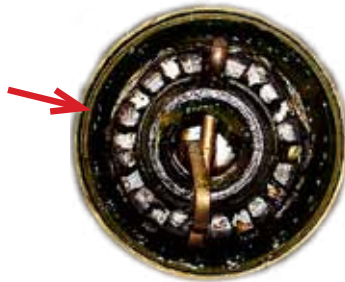
Looks can be deceiving.

Washer abuts at a 90° shoulder on tapered axle.

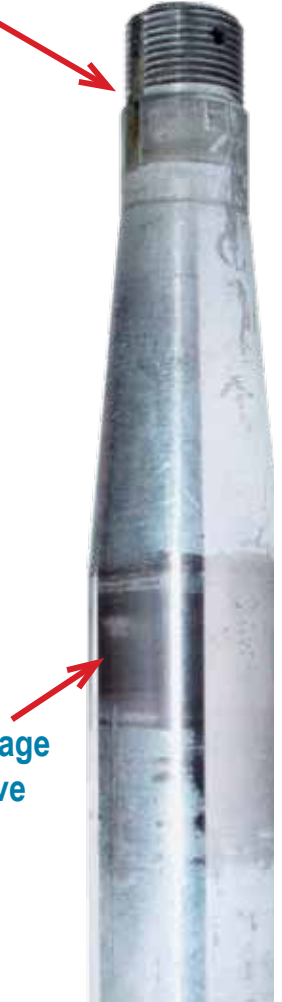
- The axle nut fails to abut the bearing.
- This results in significant endplay
- Radial & Axial damage to your axle.
- Material fatigue and fracture.
- Premature brake and tire wear.
- Increased vibration.

Radial & Axial damage  
caused by excessive  
endplay.
